**CALSPAN ON-SITE AIR BAG/CHILD FATALITY INVESTIGATION**

**CALSPAN CASE NO. 96-15**

**VEHICLE - 1995 MAZDA PROTÉGÉ'**

**LOCATION - OHIO**

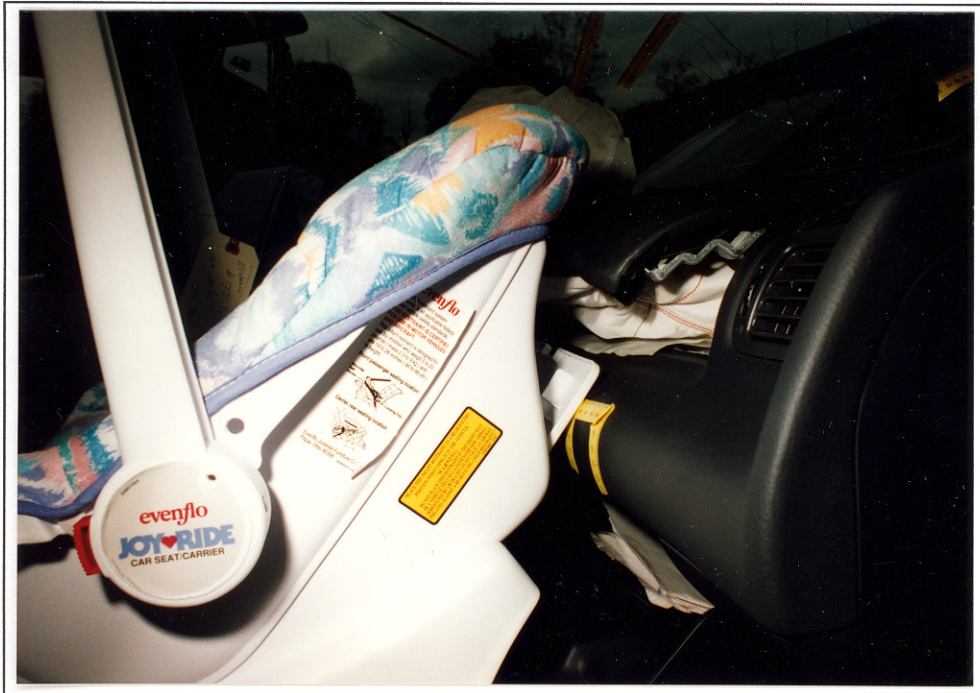
66. View of the relationship between the leading edge of the module cover and the back of the child restraint.

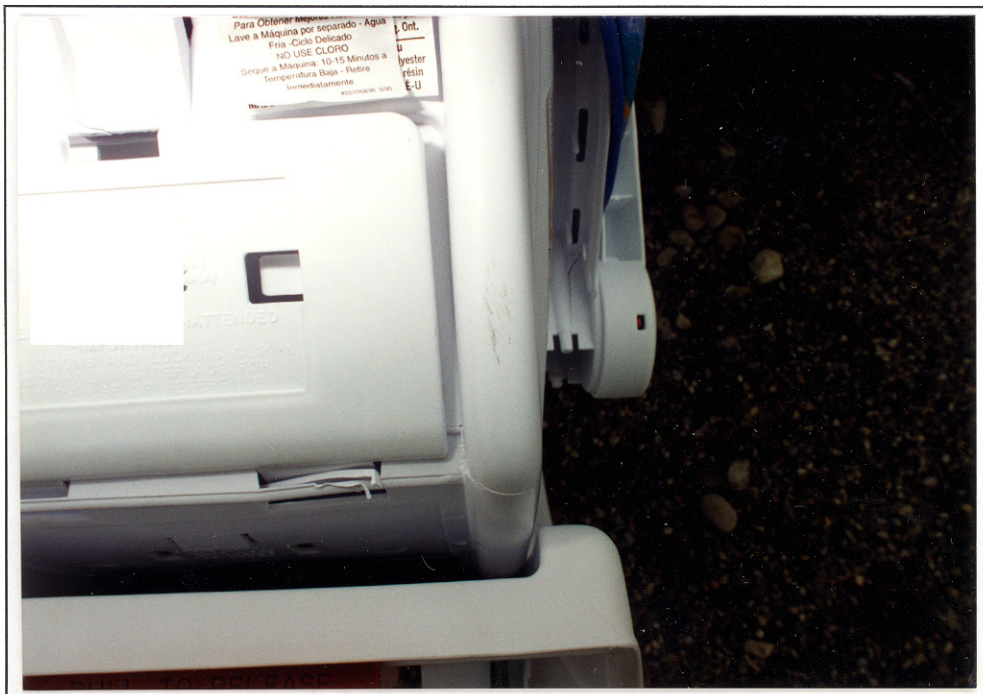
82. Close-up view of a vinyl transfer to the right side reinforcement of the child restraint.

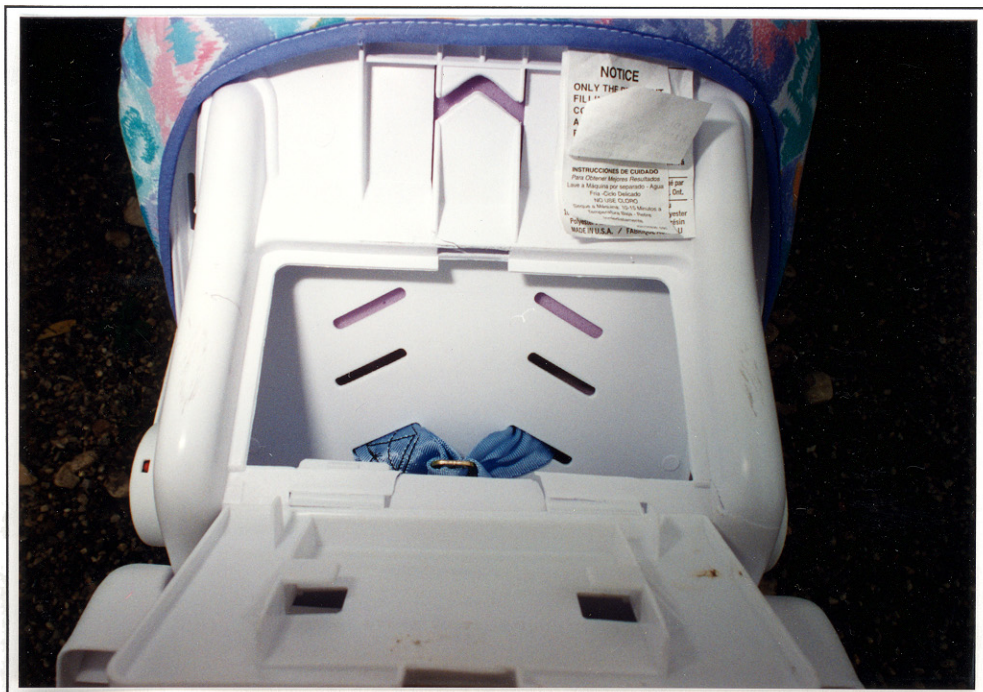
83. View of the fractured hinge of the rear compartment door.

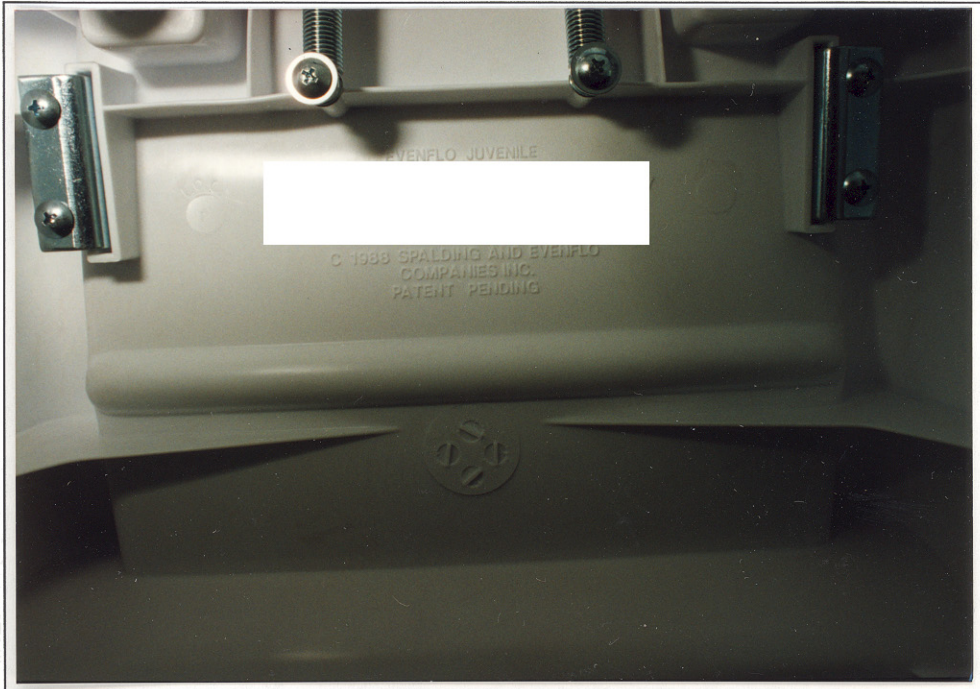
91. View of the manufacturer's molding of the child restraint.

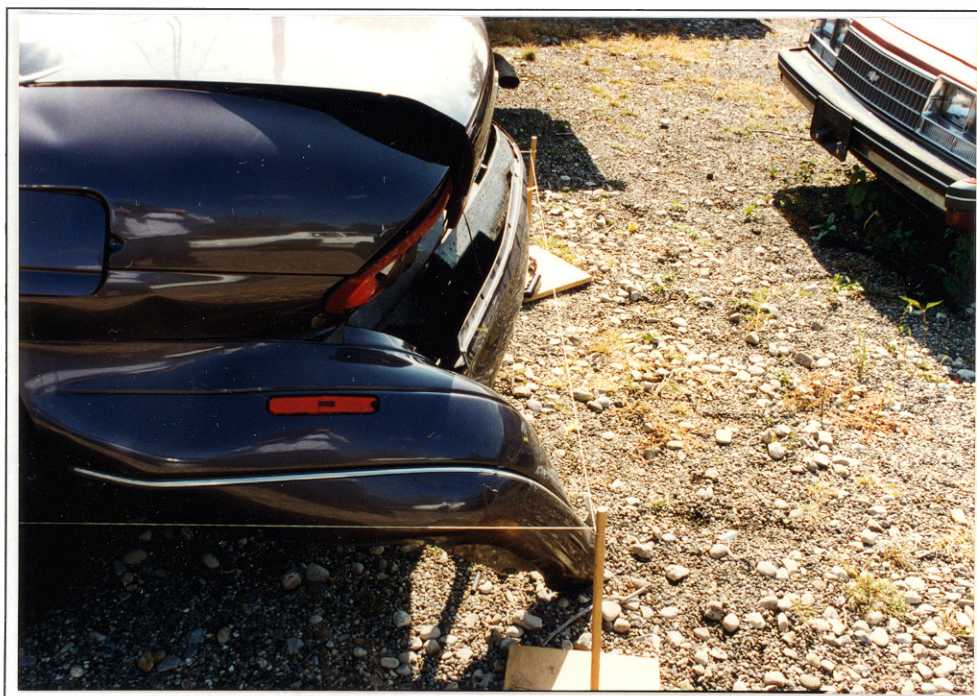
95. Left lateral view across the rear bumper.

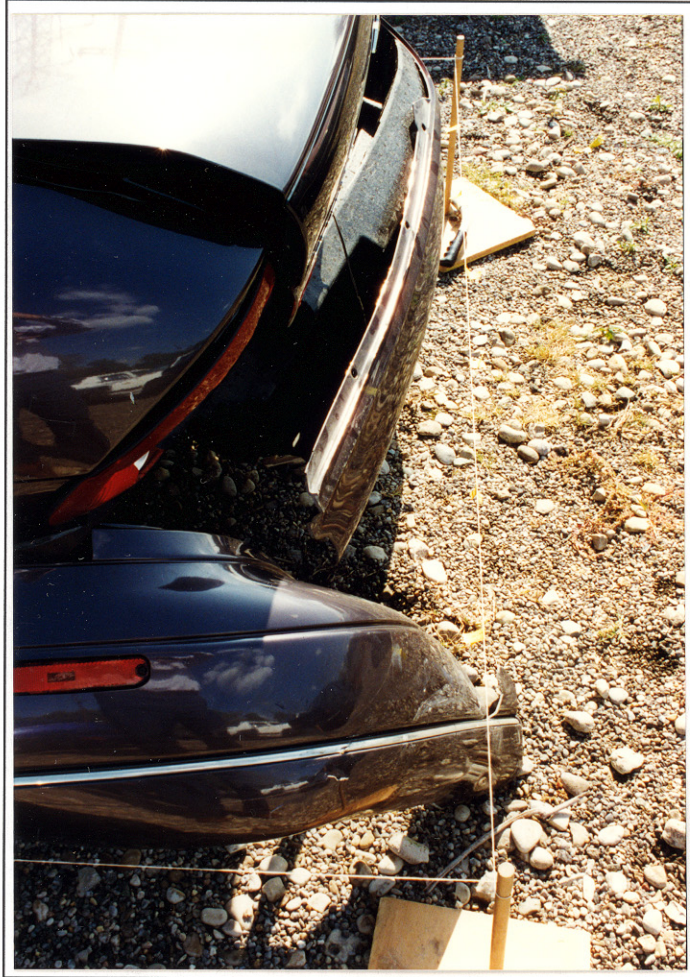
96. Lateral view of the rear bumper deformation.

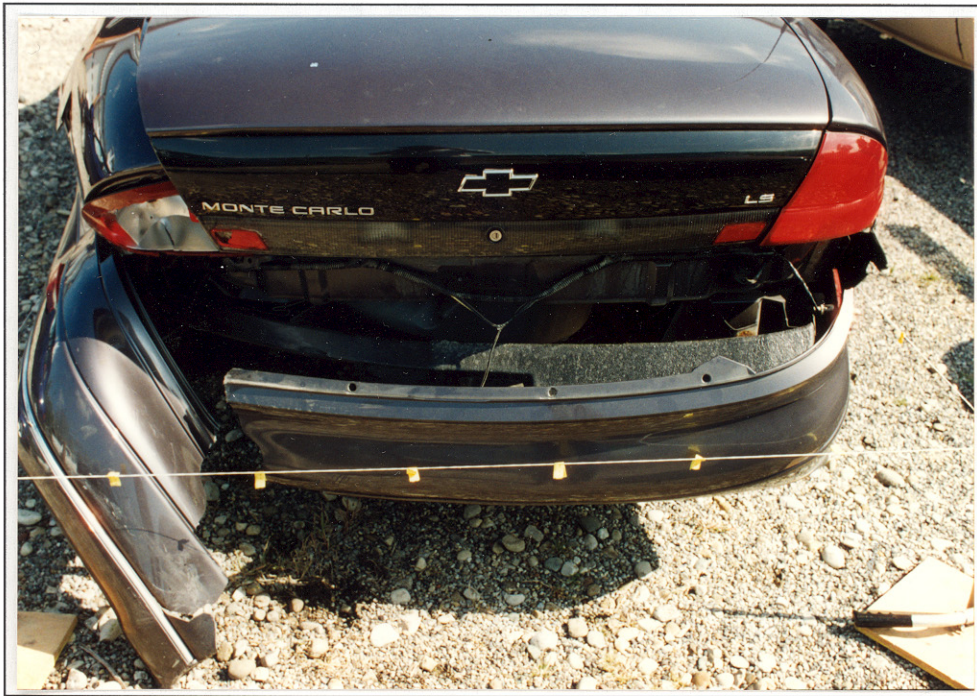
99. View of the rear bumper deformation.

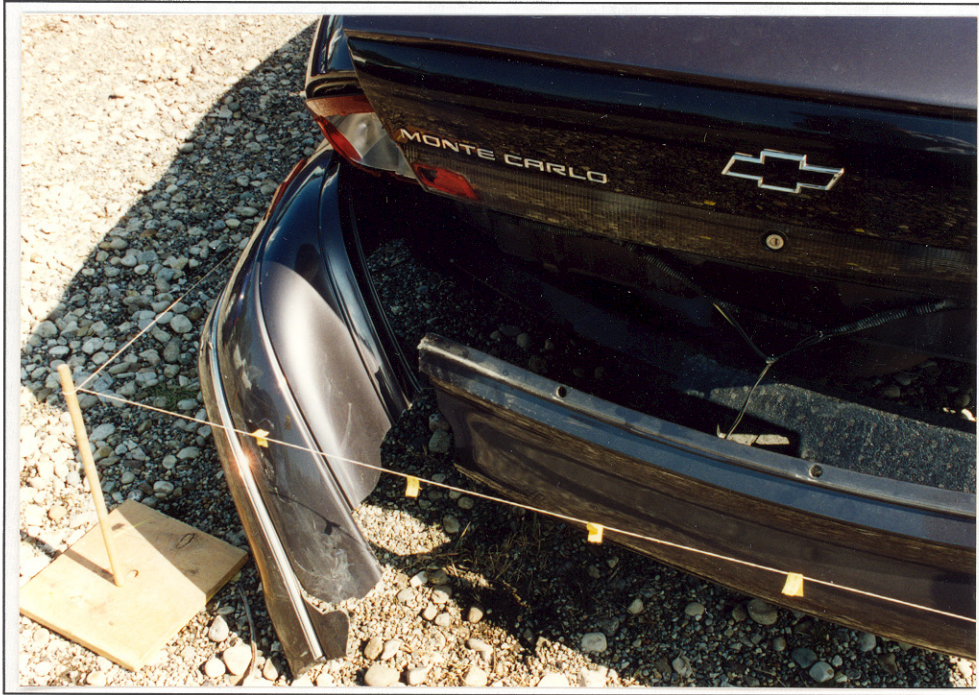
101. Close-up view of the direct contact.

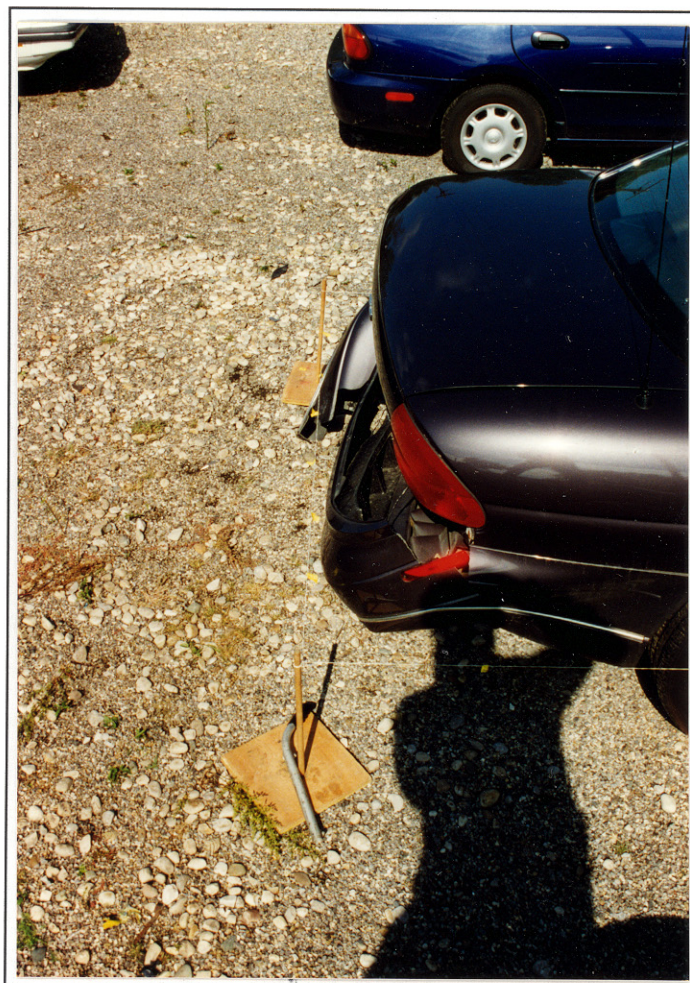
103. Right lateral view of the rear bumper deformation.
